**ATTACHMENT B**  
**VISUAL SITE INSPECTION SUMMARY AND PHOTOGRAPHS**

## **VISUAL SITE INSPECTION SUMMARY**

**Drawn Metal Products Company (Drawn Metal)**  
6143 West Howard Street  
Niles, Illinois 60648  
ILD 000 768 671

**Date:** January 26, 1993

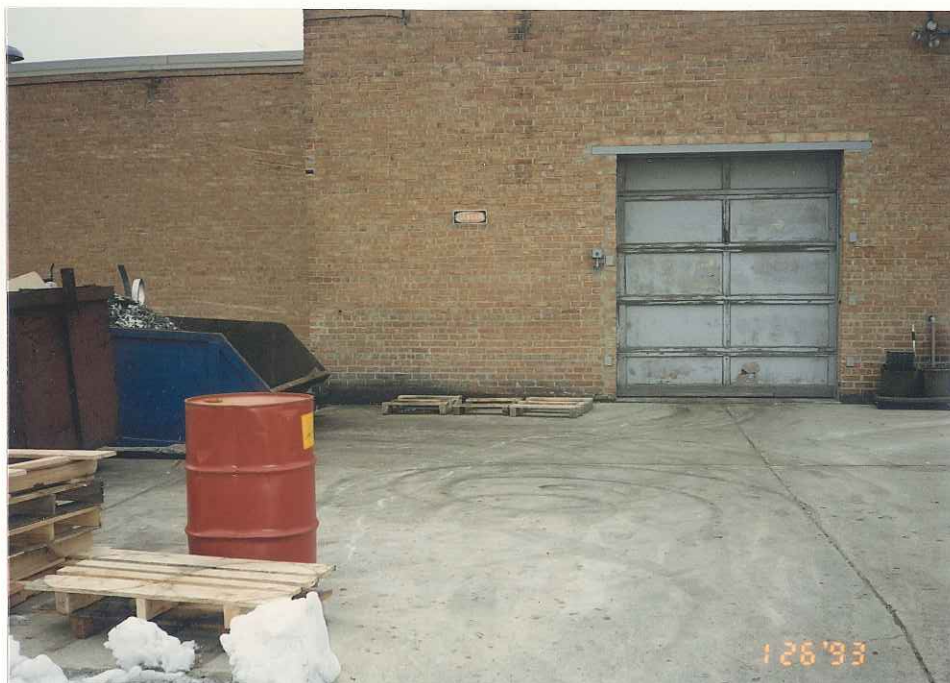
**Photograph No. 1**

**Description:** Hazardous Waste CSA containing three wooden pallets; the area south of the unit contained one 55-gallon drum of still bottoms containing TCE (F002); according to the facility representative, the 55-gallon drum was temporarily stored outside the unit because the unit had recently been shovelled after heavy snowfall during the previous week; area is surrounded by asphalt

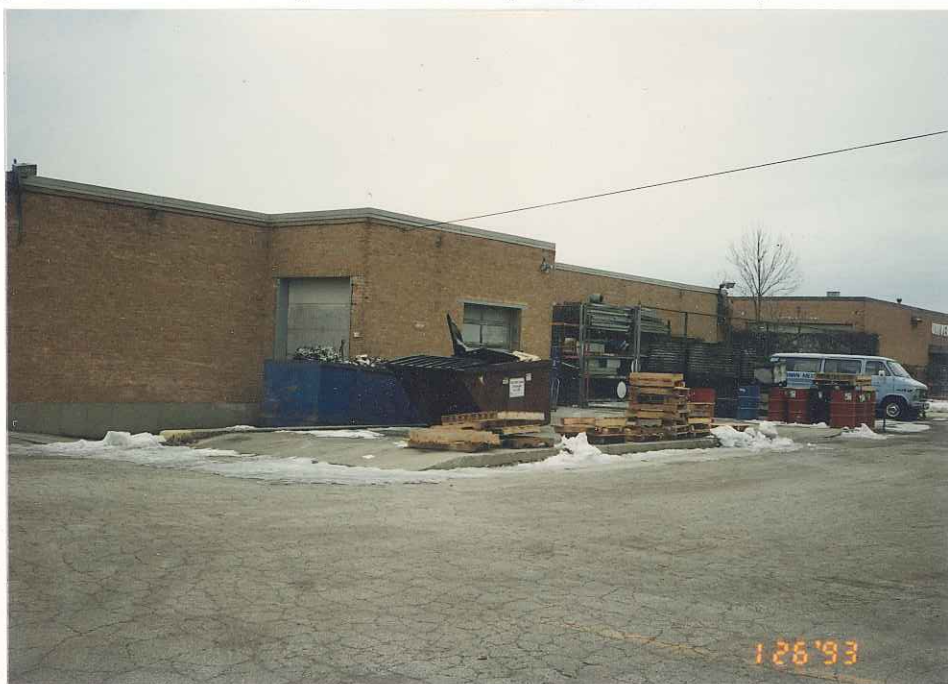
**Photograph No. 2**

**Description:** Area south of the facility that consists of the Hazardous Waste CSA, the Waste Oil CSA, the Former Waste CSA, and one of the Scrap Metal Storage Areas

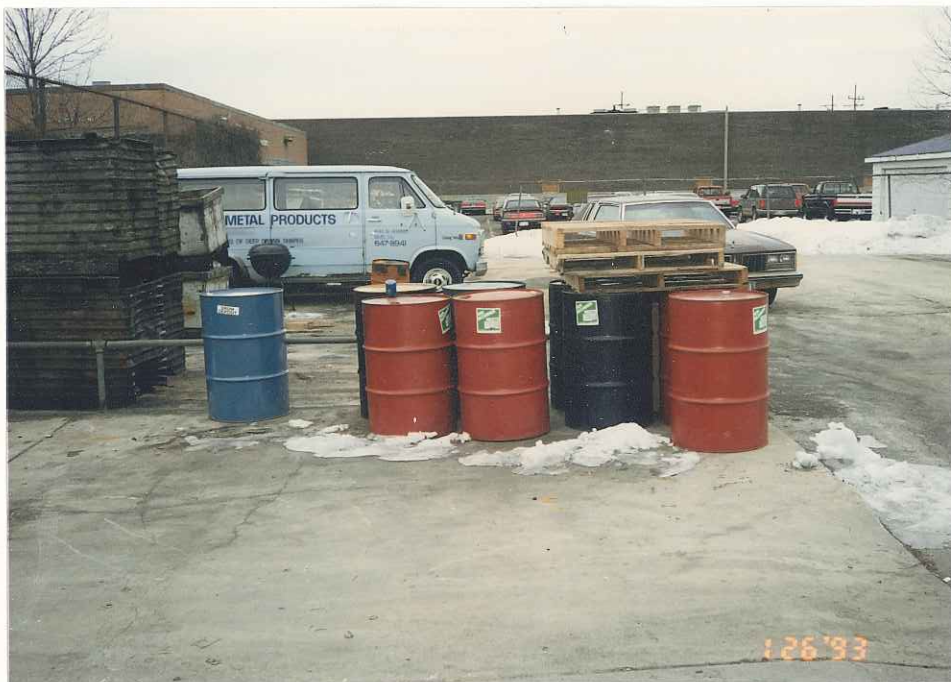
Photograph No. 4  
 Orientation: East  
 Description: Waste Oil CSA containing 10 55-gallon drums of nonhazardous waste oil; area around the unit is asphalt

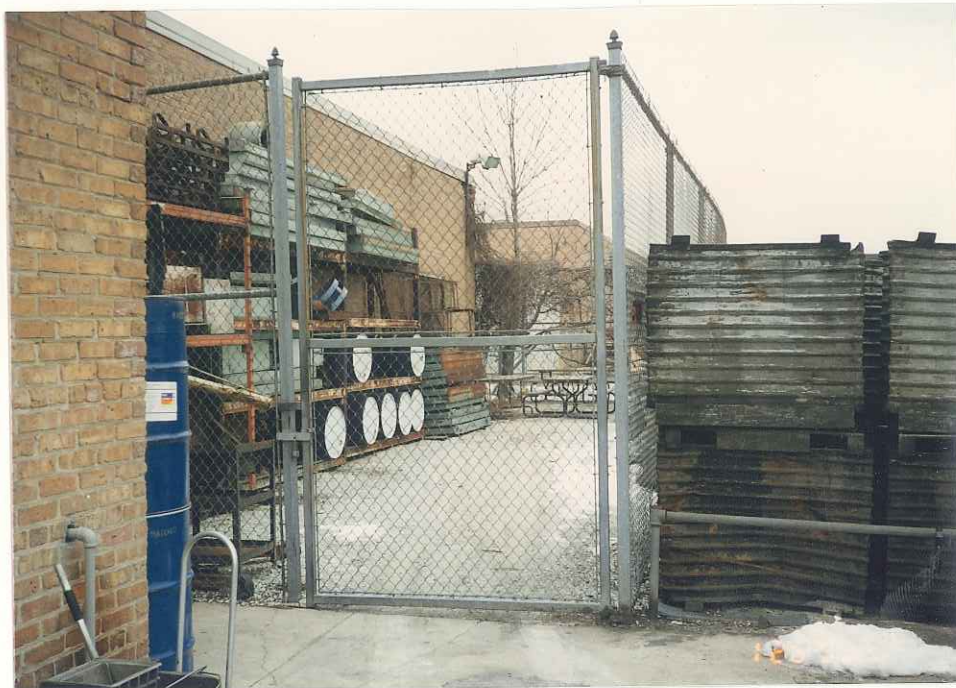
Photograph No. 5

Description: Former Waste CSA containing seven empty 55-gallon steel drums; PRC noted no stains on the gravel or evidence of spills during the VSI; area around the unit is a concrete pad to the west and southwest and asphalt to the east and south

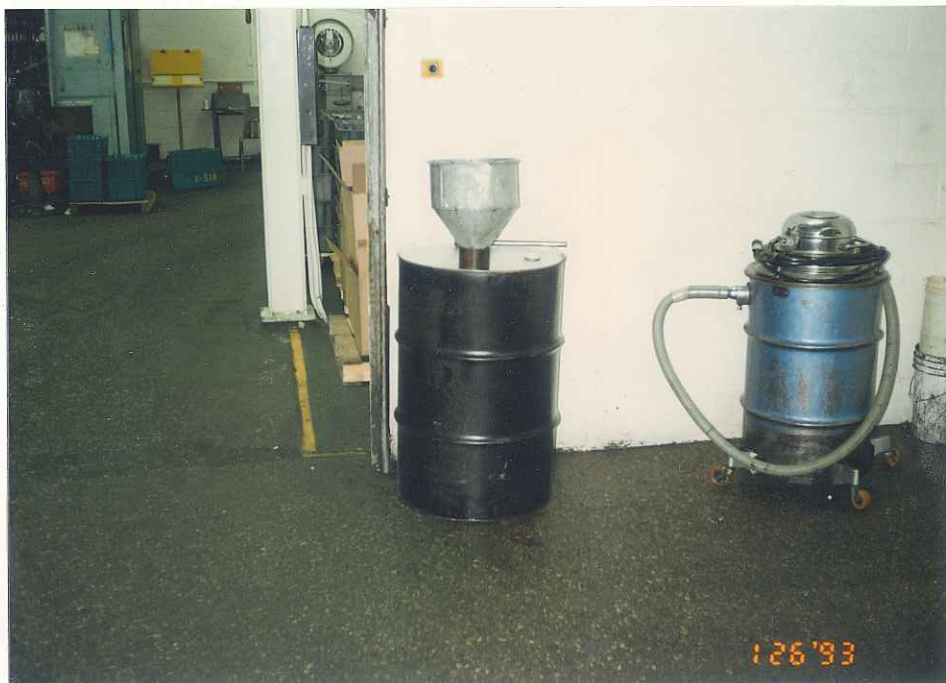
Photograph No. 6

Description: Waste Oil Accumulation Area containing one partially full, 55-gallon steel drum

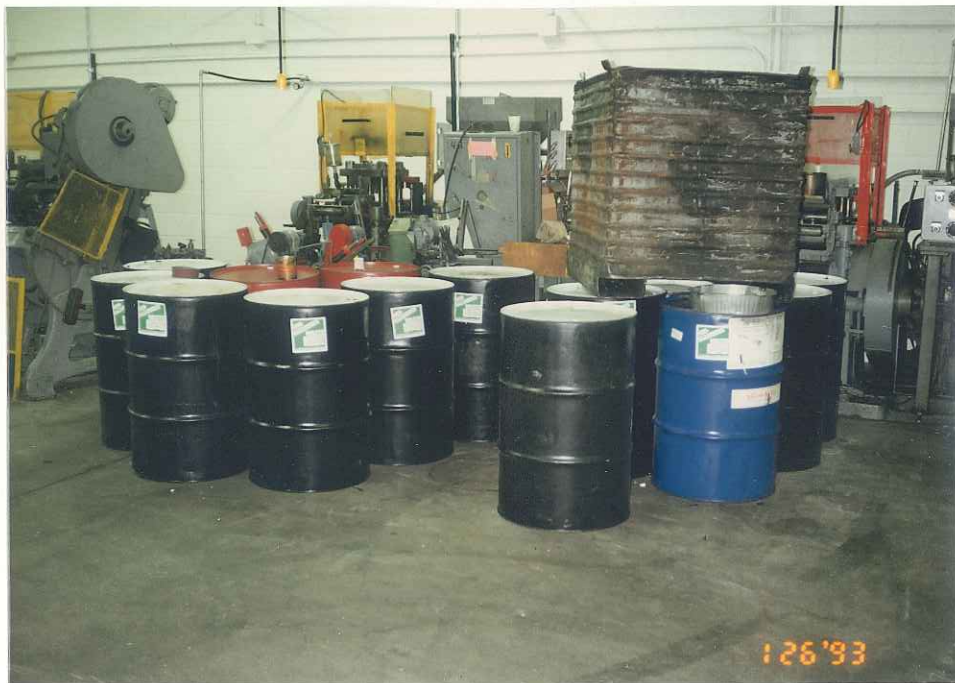
Photograph No. 7

Description: Waste Oil Staging Area containing 14 55-gallon drums of waste oil

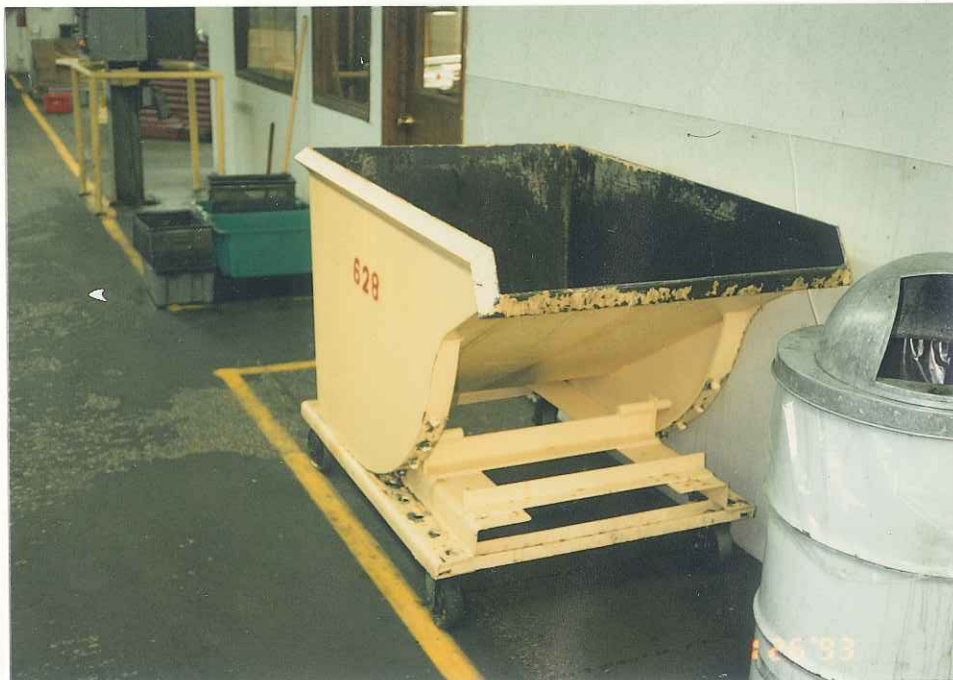
Photograph No. 8

Description: One of the Scrap Metal Accumulation Areas with a 1- to 2-cubic-yard container

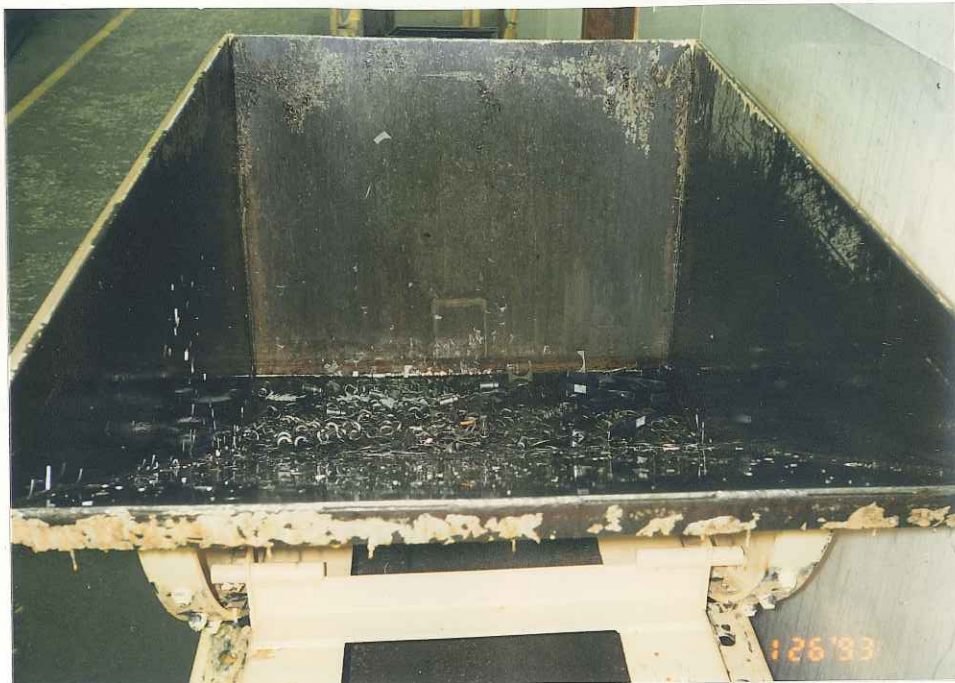
Photograph No. 9

Description: Scrap metal covered with waste oil in a 1- to 2-cubic-yard container at a Scrap Metal Accumulation Area

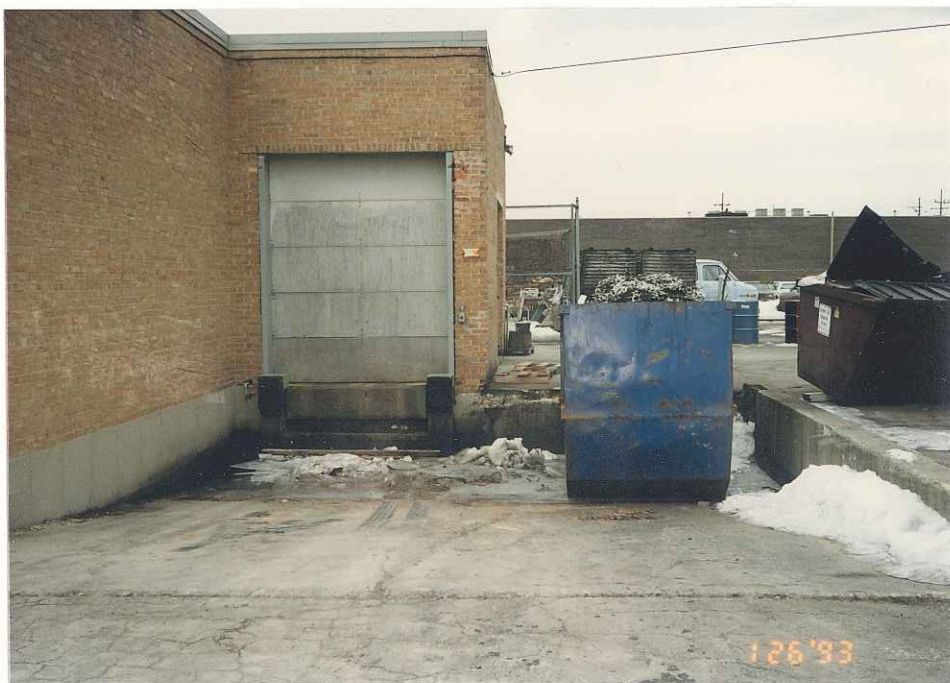
Photograph No. 10

Description: Scrap Metal Storage Area with nonhazardous waste oil stains on the concrete pad and on the facility's outside wall

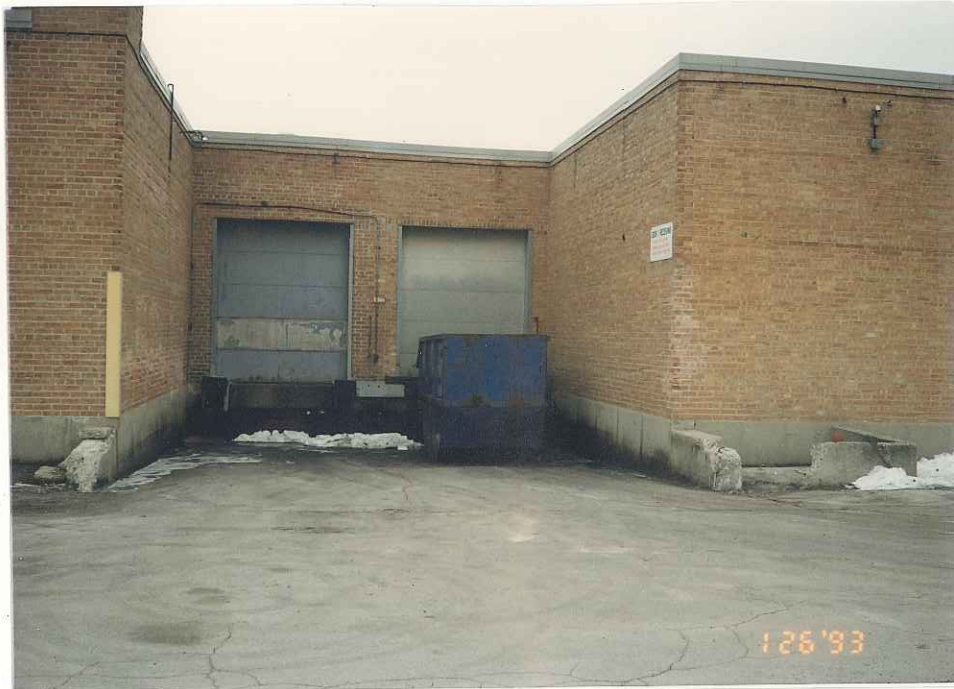
Description: Scrap Metal Storage Area with nonhazardous waste oil stains on the concrete pad  
and on the facility's outside wall
